Manhole Inspection Summary

Manhole # **S13GG1009MH**

Insp Date: **6/21/07 1:31 PM**

Location Address: **4340 PARKHEIGHTS AVE**

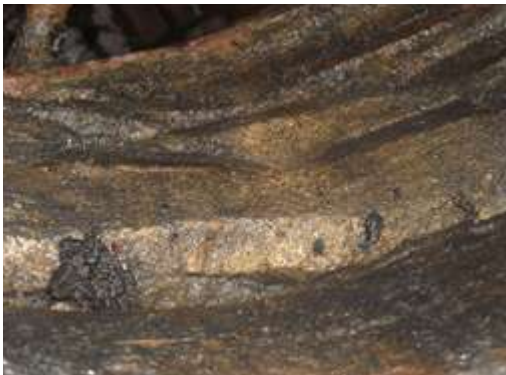
Defect 3

Offset: **1** (in.)

OFFSET FRAME

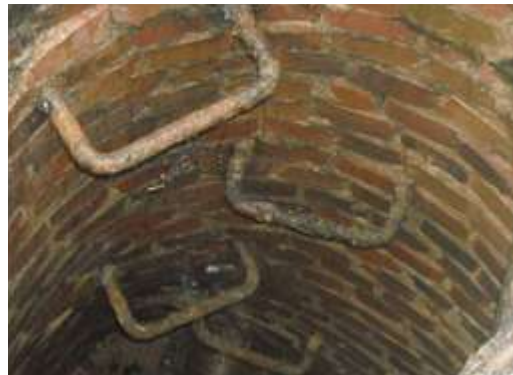
Defect 2

Count: **4** Missing: **0** ☒ **Corroded**

CORRODED STEPS

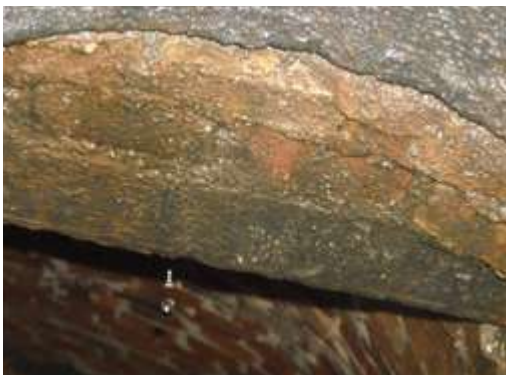
Defect 1

Infiltration: ☐ None ☒ **Joint** ☐ Cracks ☐ Mortar ☐ Roots ☐ Wall

INFILTRATION ON CORBEL

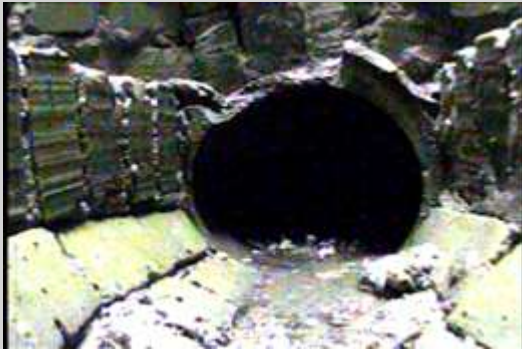
12 O'Clock Outflow

8 in. Circular Gravity Sewer
Pipe Out @ 12 O'Clock

Pipe Height: **9.6** (in.) Rod and Bar (Angled)
Pipe Material: **Clay** ☐ Pipe Lined
Invert Depth: **8.31** (ft.) Flow Characteristics: **None**
Deposits: ☒ None ☐ Mud ☐ Sludge ☐ Debris ☐ Grease
Silt Depth: (in.) Deposits Extent:
Infiltration: **None** Pipe Seal Cond: **Broken**

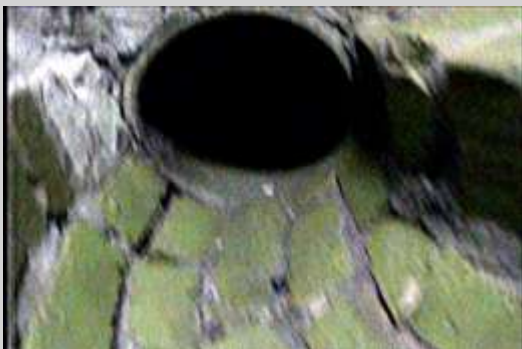
6 O'Clock Inflow

8 in. Circular Gravity Sewer
Pipe In @ 6 O'Clock

Pipe Height: **7.2** (in.) Rod and Bar (Angled)
Pipe Material: **Clay** ☐ Pipe Lined
Invert Depth: **8.05** (ft.) Flow Characteristics: **None**
Deposits: ☒ None ☐ Mud ☐ Sludge ☐ Debris ☐ Grease
Silt Depth: (in.) Deposits Extent:
Infiltration: **None** Pipe Seal Cond: **Sound**
